SEVENTH SEMIANNUAL STATUS REPORT
VOLUME II - APPENDIX A

ENERGY EFFICIENT ENGINE
COMPONENT DEVELOPMENT AND INTEGRATION PROGRAM

**ENERGY EFFICIENT ENGINE
HOLLOW FAN BLADES**

FINAL TECHNICAL REPORT

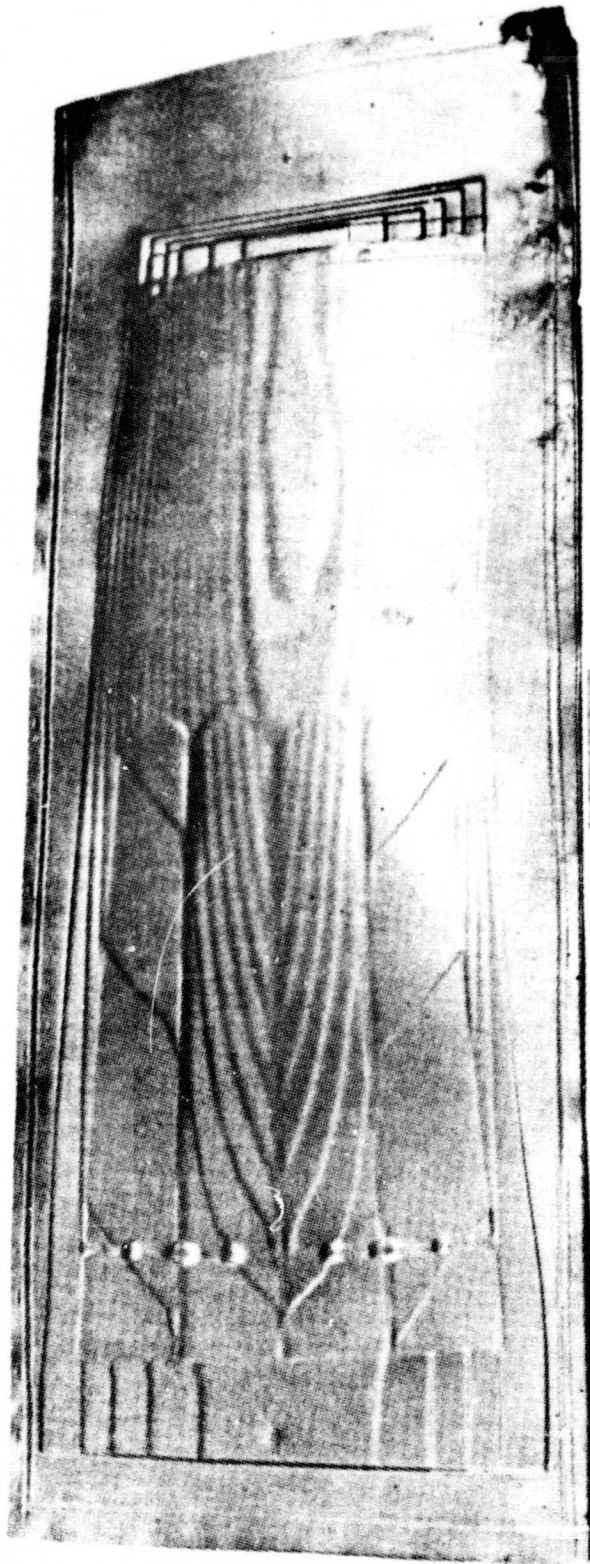
The HIP cycle used at IMT was, again, the 4.5 hours at 1750°F temperature cycle previously used. Visual observations of both blades after HIP indicated that 4 appeared to be a good, well-bonded blade while 5 leaked during HIP. Blades 4 and 5 are shown after HIP in Figures 83 and 84. As shown in Figure 83, there is considerable surface detail due to ply endings, cores, etc. The blade also "rings" when tapped with a metallic object, which is an indication of bonding. X-rays of the blade indicated good core location with no evidence of ply endings (sharp lines in the X-ray film would indicate a lack of a good bond). However, there does appear to be some deformation of the "pins" located at the edge of the cores. The Figure 85 X-ray indicates these observations. These "pins" were added for passageways for acid core leaching. There appears also to be a relationship between the "pins" and "bumps" on the surface as shown in Figure 83. The bumps are excess titanium from the central plies.

Figure 83. AS-HIP Blade 4.

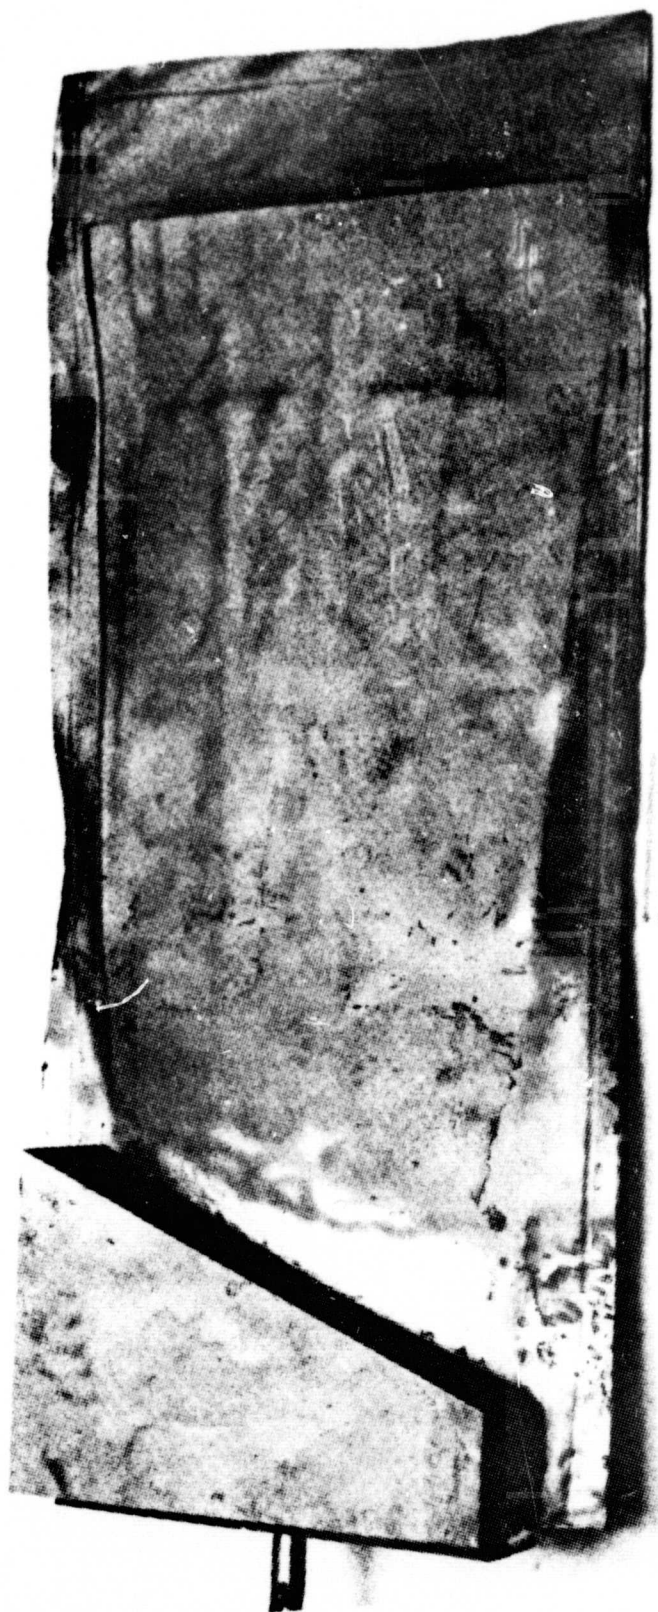
Inspection of blade 5 with the root indicated leaks in several areas, the more prominent being in the canning sheet-root block interface towards the tip which were either seam or spot welded. Other leaks in the blade were observed, but found to be inconclusive due to lack of reproducibility. It appears that the leaks in the canning sheet-root interface were quite large leading to excessive helium in the area. This excessive helium discharge makes leak detection difficult. Based on the above observations, it appears that there was too much can collapsing in the canning sheet-root block area. High shear stresses and thin cover sheets contribute to these weld failures. It is doubtful that this canning approach can work with the current ply and root designs.

Figure 84. AS-HIP Blade 5.

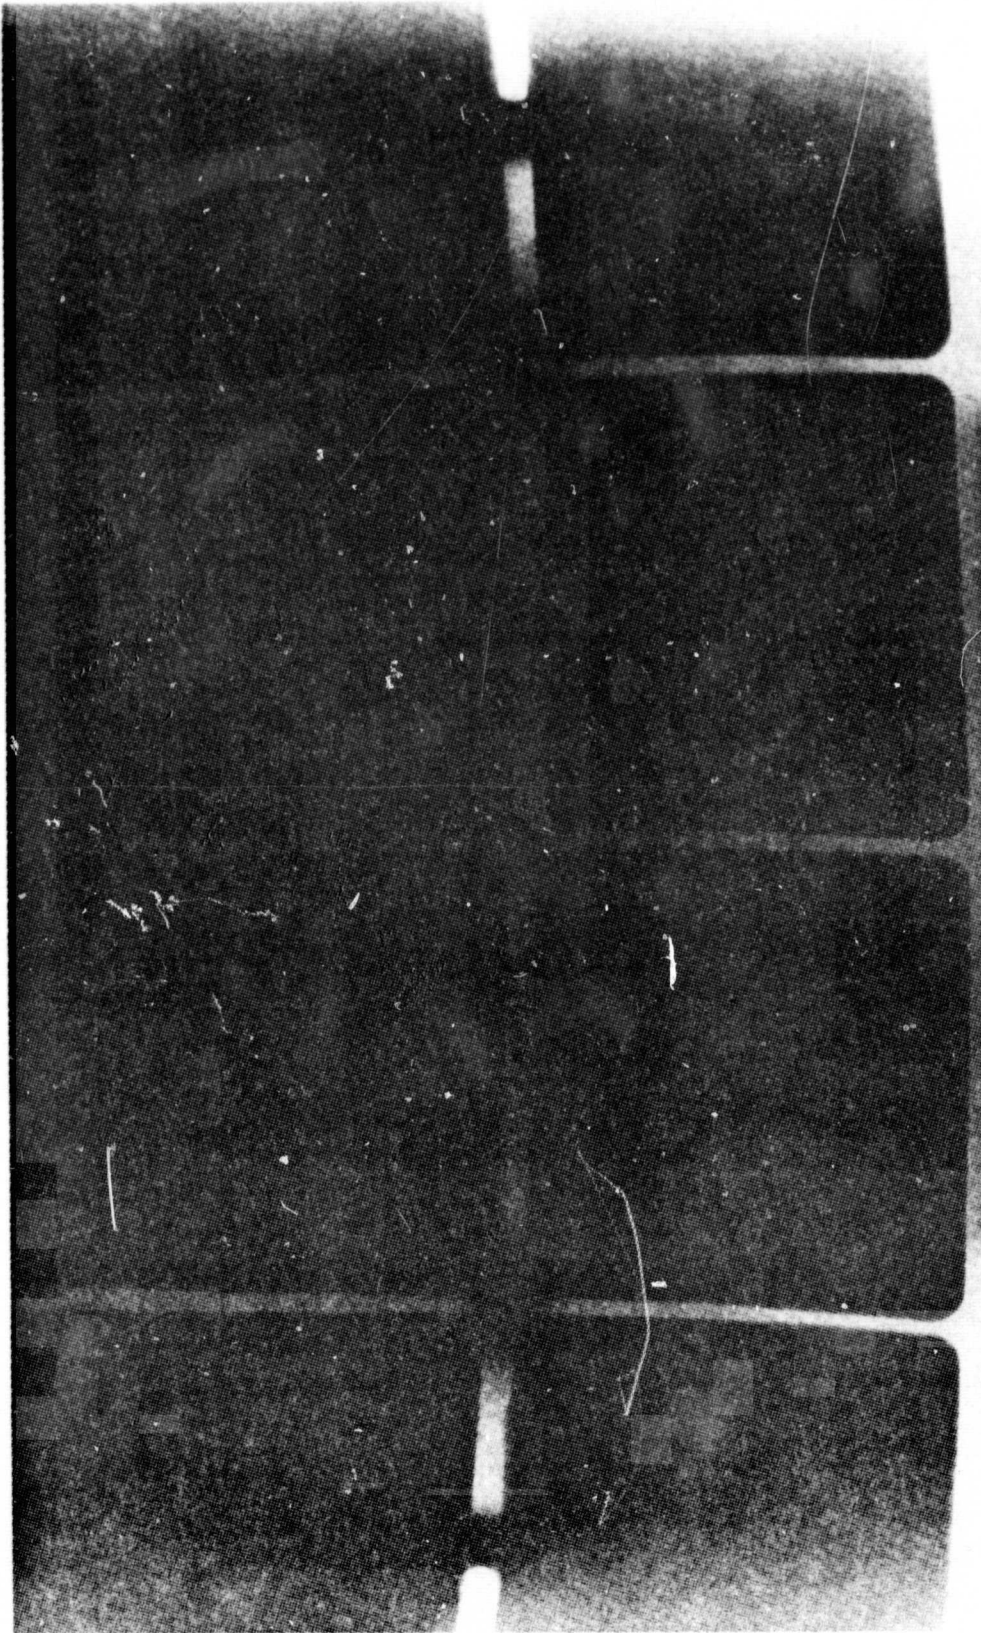
Figure 85. X-Ray of Tip Area of Blade 4.

Previous results on blade 4 described what appeared to be deformation of the connecting pins of the cores as a result of the HIP operation. These observations were based on X-rays of blade 4 and were again observed for blades 6 through 9 even though excess titanium was removed from this area prior to assembly. There was some thought that the image observed in these areas on the X-ray film may be the excess titanium ("bumps") on the surface that can be seen after HIP. These "bumps" were removed from blade 4 by grinding and the blade was resubmitted for X-ray. The new X-rays revealed evidence of pin deformation. To alleviate this problem in the future, it appears that the pins between cores will have to be placed at greater distances apart than for the current design.

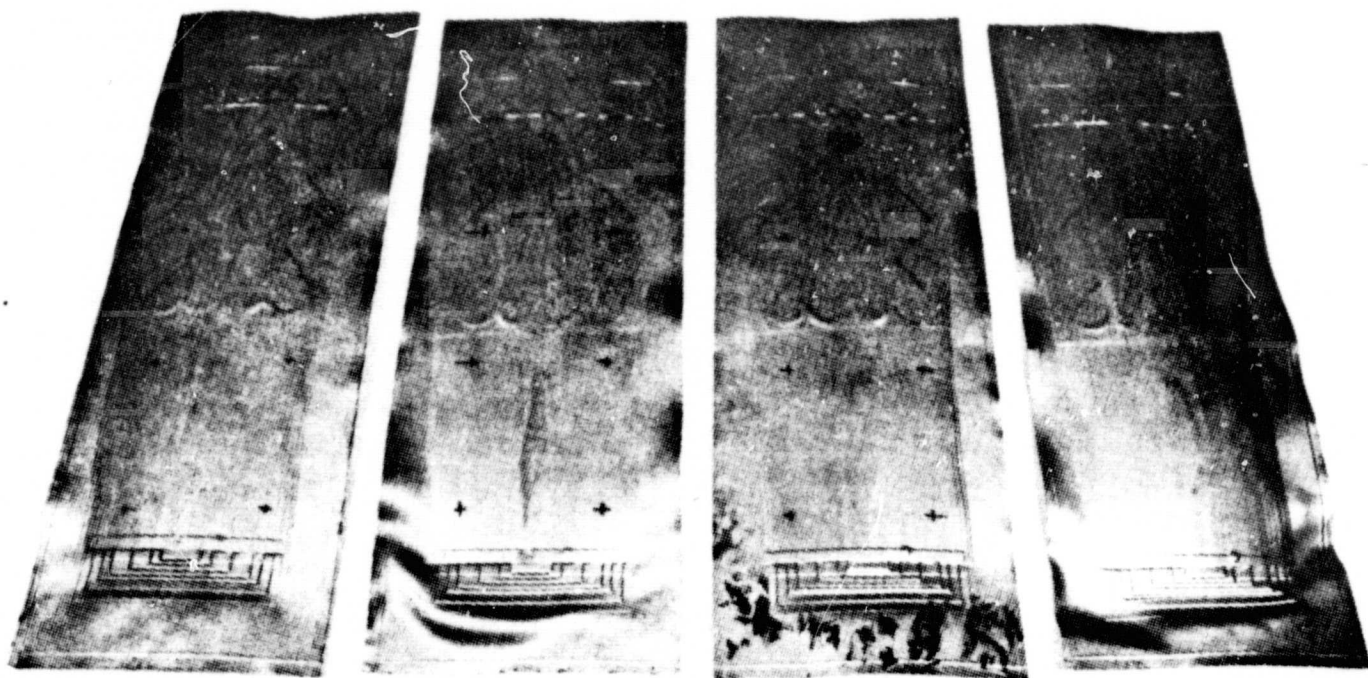
Visual and X-ray results of blades 6 through 9 indicated that the four blades were successfully bonded by HIP (see Figure 86). To measure the amount of can collapse after sealing and HIP, the thicknesses at eight points were measured along the length of the blades at a distance of 4-inches from the edges. These results are shown in Table IV. The measurements were made using hand micrometers and were only intended to give some indication as to the amount of can collapse and debulking that occurs. After sealing an average can collapse of 0.15-inch was observed with more collapsing being observed at the root end. An average debulk of 0.10-inch was observed as a result of the HIP operation, and again more debulk was observed at the root end.

Figure 86. Blades 6 Through 9 Shown After HIP.

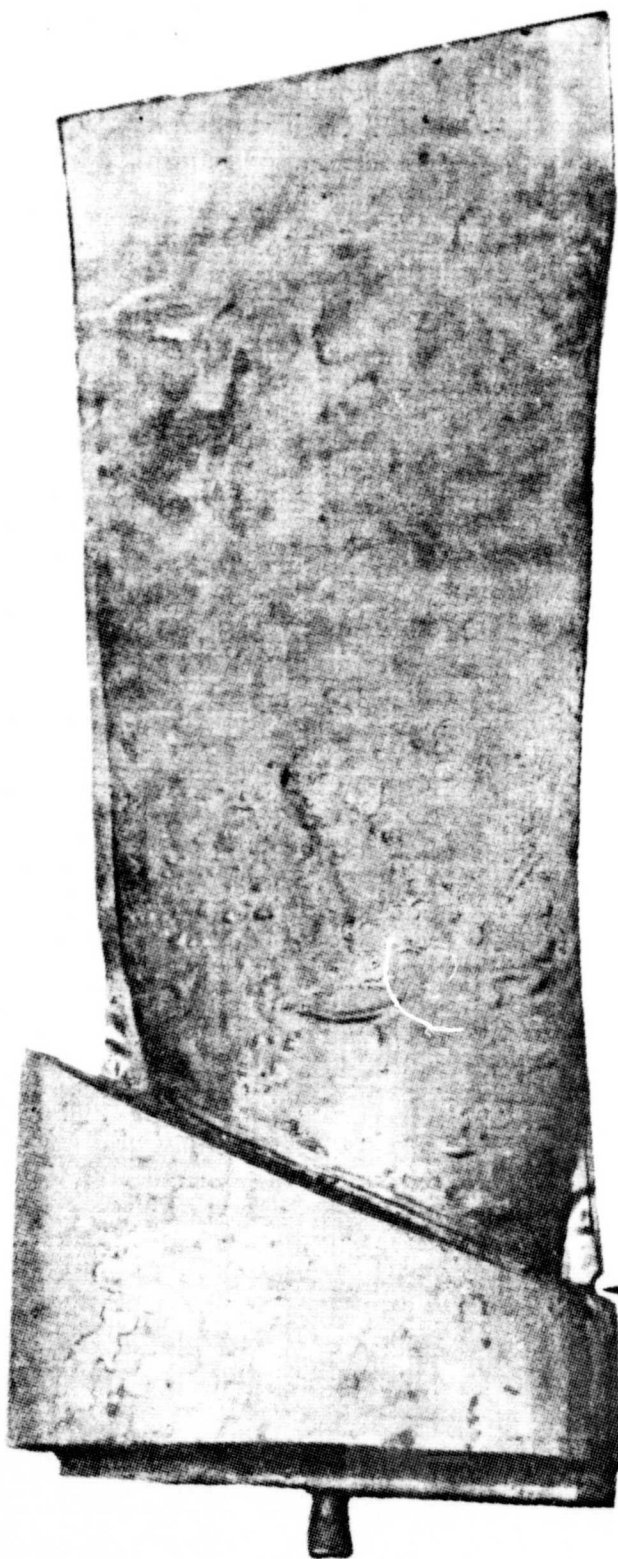
a. Cambered Blade

Blade 2 is shown after cambering in Figure 87(a). Basically, the concept of cambering a flat blade layup after HIP appears very promising. There was some severe tearing observed at the leading and trailing edge areas of the airfoil-root interface as shown in Figure 87(b). The tearing occurred because the die and punch made contact with the airfoil prior to making contact with the root. Tooling rework was performed in this area.

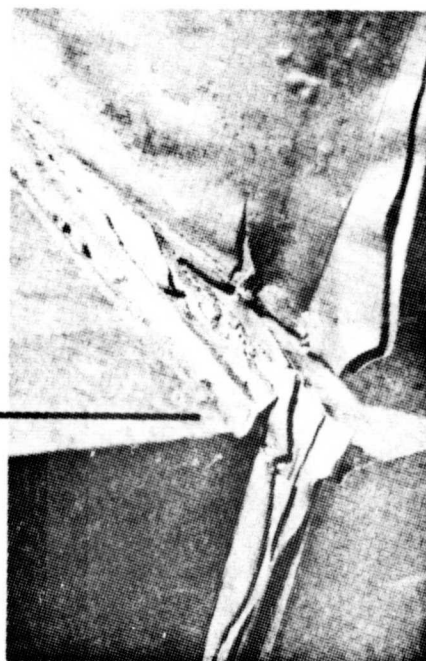
b. Airfoil Root Tearing

Figure 87. Blade 2 After Cambering.

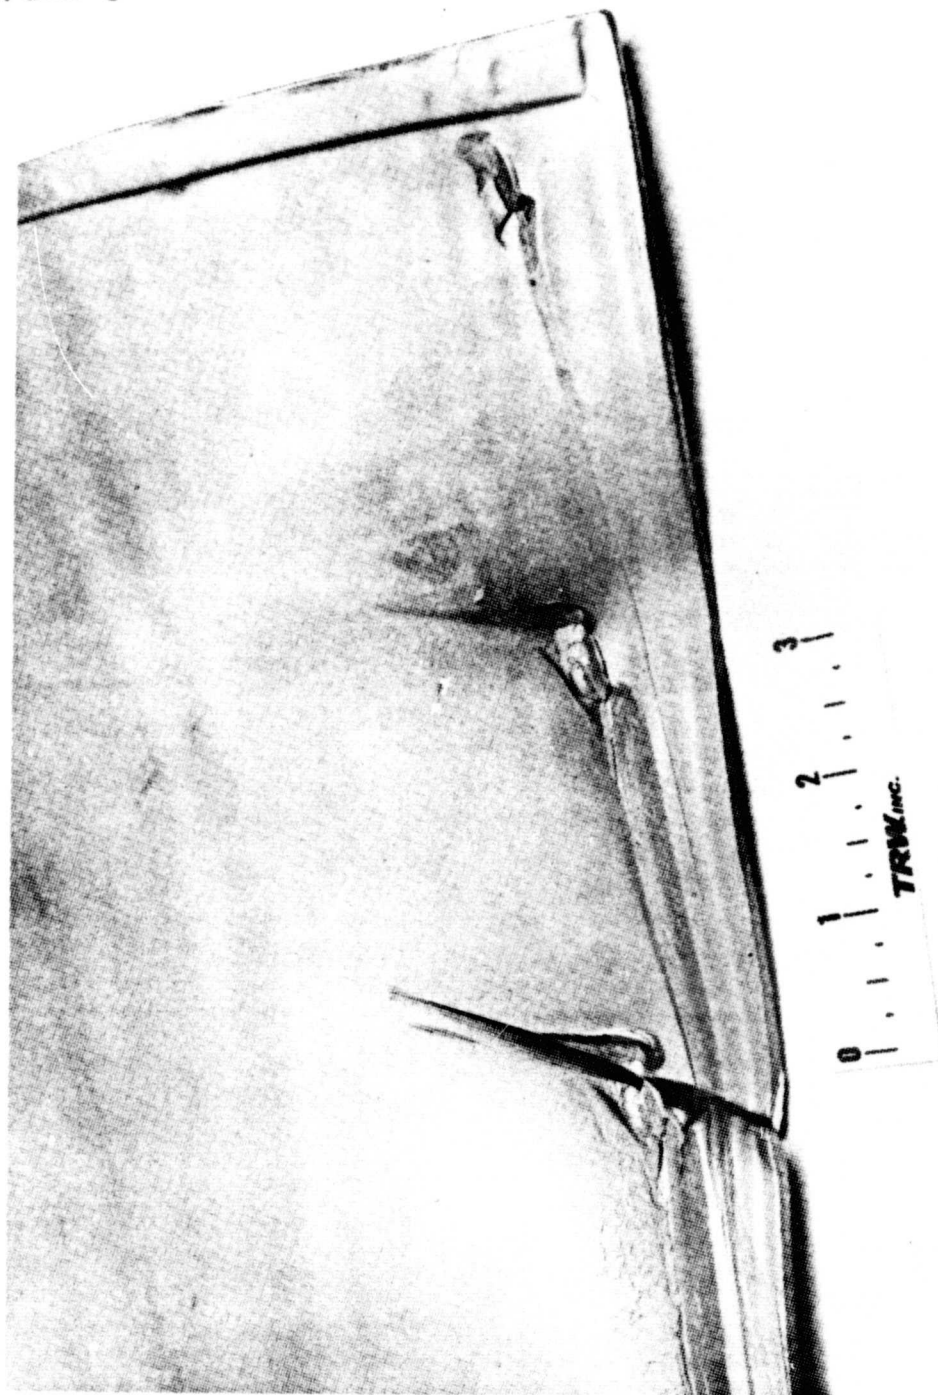
After rework blade 4 was cambered. The cambering process for blade 4 resulted in severe tearing near the leading and trailing edges at the intended root/airfoil interface area as shown in Figure 88. The tearing was still attributed to an early contact problem in this area and also to long transfer times causing excessive blade chilling. The upper punch was removed from the press for rework and some modifications.

Figure 88. Shear Area as a Result of Cambering for Blade 4.

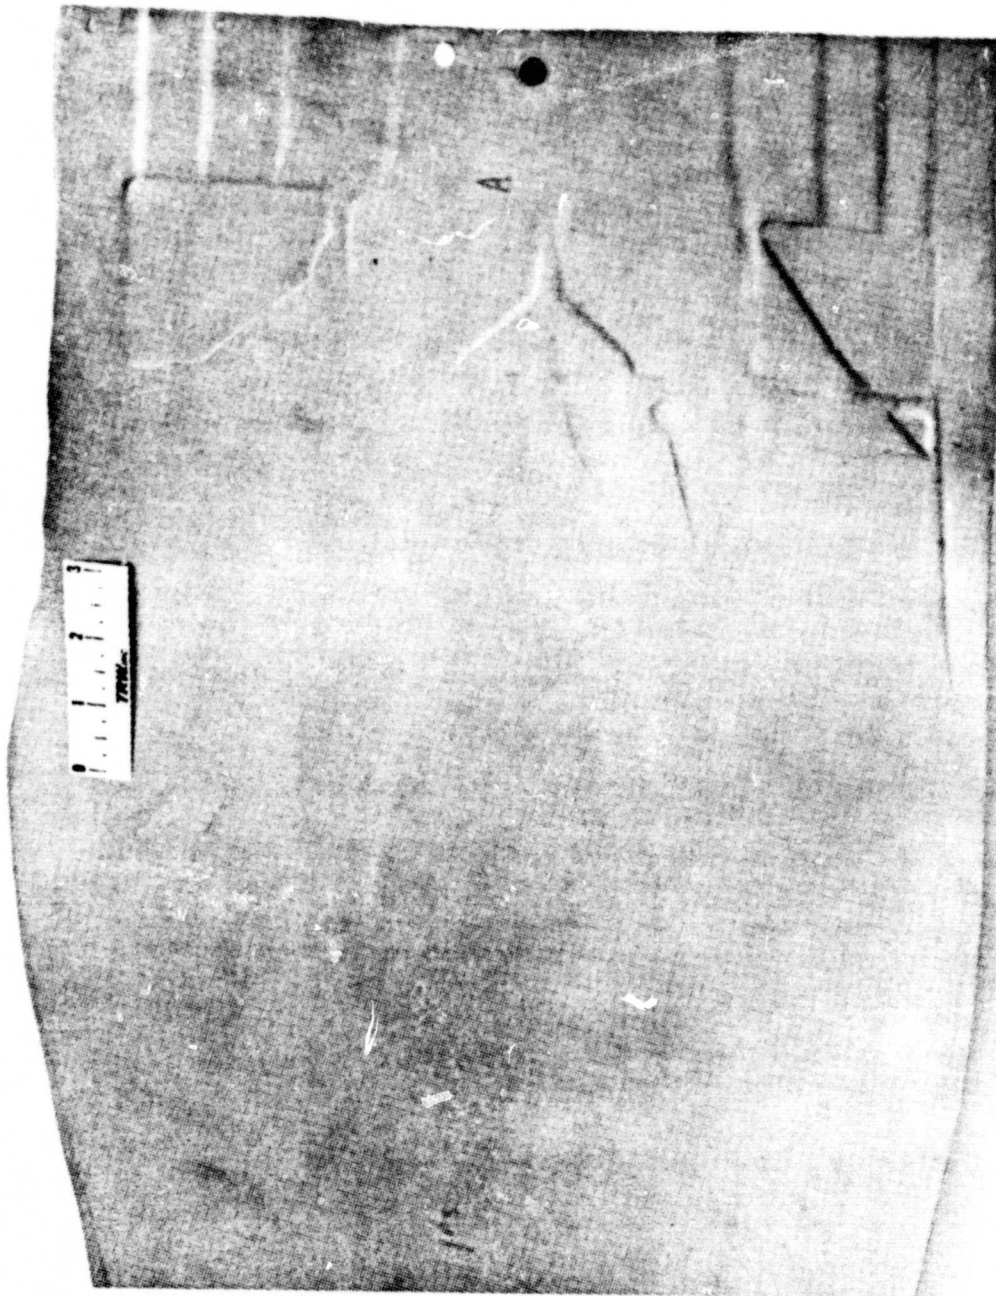
Figure 93. Tip Section of Blade 7 After Isothermal Forging Showing Lack of Contact During Forging in This Area as Indicated by Ply Endings Present on Surface.

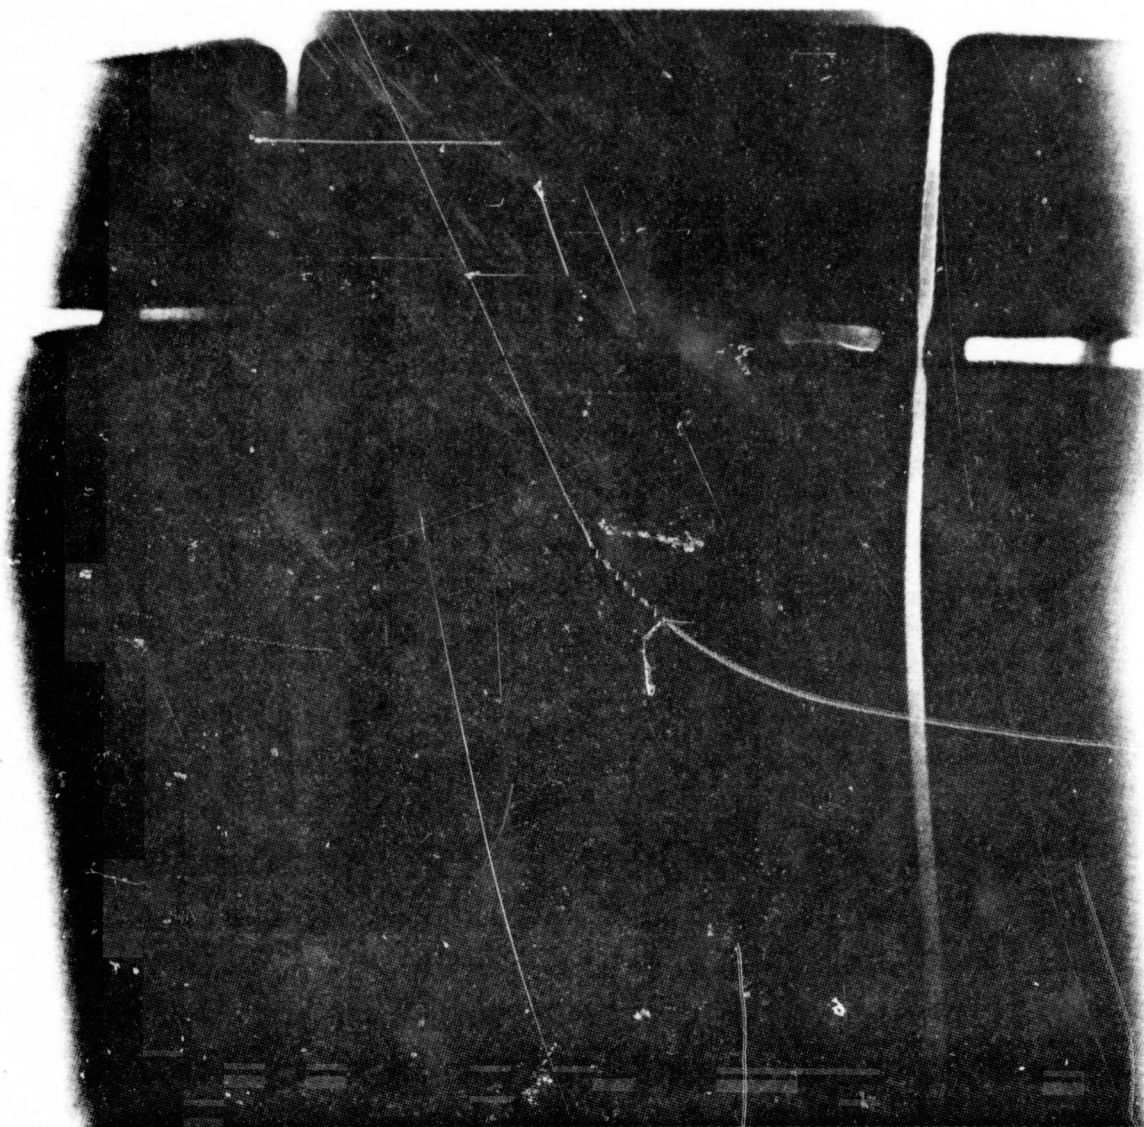
Other evaluations of the blade included X-ray analyses. All five blades were X-rayed. There was no evidence of disbond areas within the blade based on experience in interpreting X-ray film for diamond specimens. A typical X-ray is shown in Figure 94 for the core section of blade 7. It was found that the cores at the leading and trailing edges flowed during forging following the flash pattern. That is areas where more material flashing occurred resulted in more core flow in these areas. This phenomena can be observed in the Figure 94 X-ray. The X-rays also indicated that the cores had increased in length as a result of the forging operation. It was noted that the overall blade length was increasing during forging by approximately 1-inch. Core length changes are shown in

Figure 94. X-Ray Showing Lateral Core Movement Due to Isothermal Forging.

Table X. For some reason the change in length was not identical for the two blades. The edge cores seemed to elongate more than those in the central portion of the blade. The forging reductions were selected because of the need to "iron out" the surface undulations from the plies; however, based on the camber trials not much more than a "squeezing" operation may be required to eliminate the surface undulations. Thus the core deformation can be reduced by programming less blade deformation.

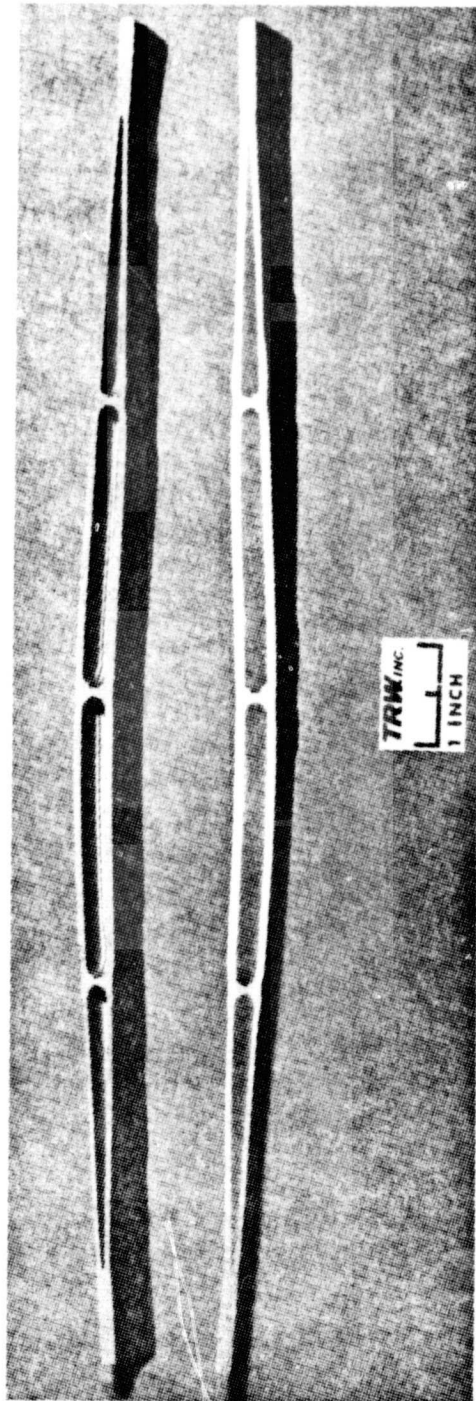
Blades 7, 8 and 9 were saved for machining while blades 4 and 6 were sectioned for core cavity and metallographic evaluations. Blade 4 was cut at approximately section AM-AM, AG-AG and AF-AF. Section AM-AM is near the tip and is oversize in thickness. This section, Figure 95, shows what the surface of the core end looks like internally. What is obvious are ridges from each individual ply. Section AG-AG, Figure 96, shows a typical view of a section that meets pitch thickness tolerance. The wall thickness was measured for this section and the data are presented in Table XI. It was found that the wall thicknesses met blueprint requirements. This result would lead one to suggest that, when properly designed with respect to volume distribution, wall thickness requirements can be maintained. Figure 97, section AF-AF, shows the typical internal surface condition. There are 0.030-inch steps internally as a result of ply endings on the core surfaces. Figure 98 are photos of typical longitudinal sections through blade 6. Similar surface and edge conditions exist.

Figure 95. Section AM-AM of Blade 4. Top Piece Shown Has Core Removed.

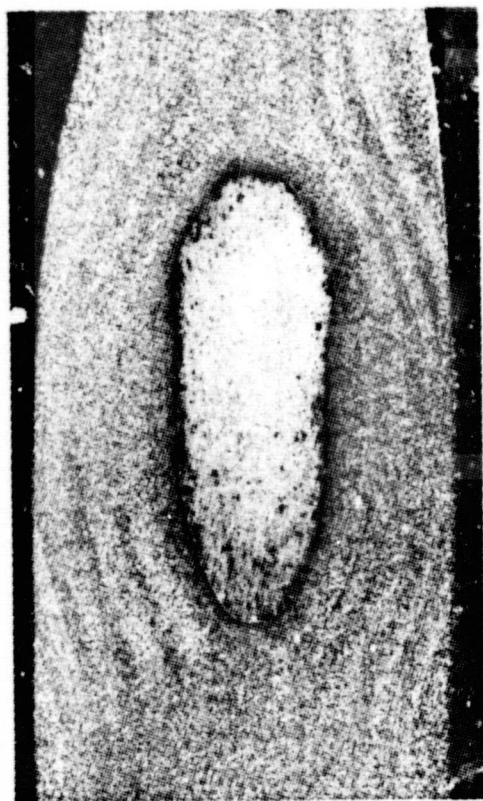
a. Connecting Pin Between Upper and Lower Core Sections

Figure 99 is a series of photomacrographs and photomicrographs illustrating various surface conditions at the core edges for blade 4. Figure 99(a) shows that the connecting pin between the upper core section and lower core section experienced substantial deformation during HIP. The pin was deformed approximately 25%. This area is at the tip which saw no deformation during isothermal forging. Figure 99(b) shows an area through both core sections and the pin. While 99(c) shows an area between the two core sections. The nature of the steps indicates both core flow and ply indentation occurred during HIP. Figure 99(d) depicts a condition at the core end at the root. At this area it appears that rather severe core indentation occurred. Figure 99(e) and (f) are sections between cores (transverse sections) illustrating typical surface condition at the radii. These areas appeared to be more uniformly indented rather than a condition shown in 99(d) for the core end. Figure 99(g) shows the condition at the edge of a core at the blade edge. Figures 99(d) through (g) are from a heavily deformed area of blade 4. For all the sections evaluated there was no evidence of voids due to lack of fill. The gaps shown in Figure 99 between core and HIP laminates are the result of shrinkage during cooling. One of the obvious conclusions from the above series of photomicrographs was that core indentation was more severe for the blades than it was for the diamond specimens. In order to solve this problem a stronger core material will have to be used, but one that has a better thermal expansion match than the TRW VMS-478 alloy in order to prevent crack problems due to high stress conditions.

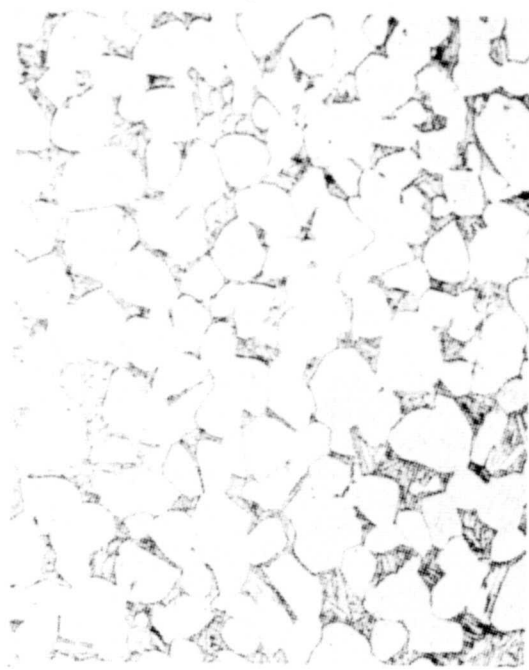
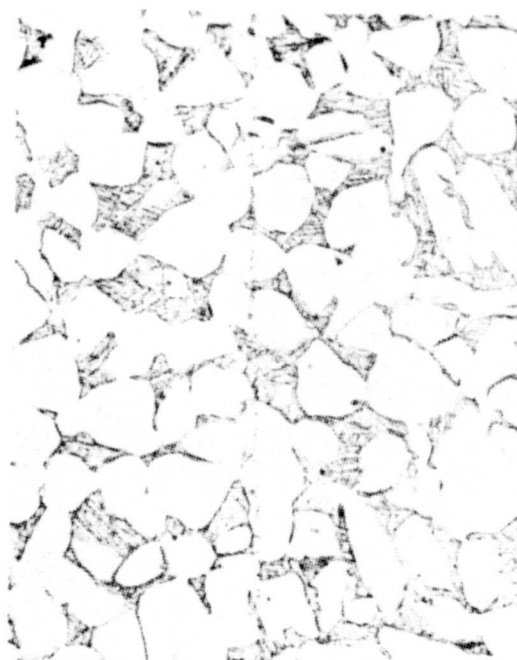
Figure 100. Microstructure Observed for Blade 4.

at the bond lines using standard etching. The material was given a heavy etch and some evidence of "micropores" was found as shown in Figure 100; however, this condition was observed in less than 5% of the possible bond lines examined.

- o Demonstrated that core materials having a carbon content equivalent to AISI 1045 successfully avoid any core/laminate interactions.
- o Problem with "micropores" at the laminate interface was observed. Whether these "micropores" are the result of cleaning procedures, contaminants, preferential etching or are possibly related to the fact that the process is conducted in a static vacuum is probably still not understood. It is recommended that an extensive effort in material preparation on test samples be considered to define the problem.
